## Case 417 : Narrative

Case Vehicle (A): 1998 Honda	Vehicle (B): 2000 Buick
Type: Accord LX, 4-door sedan	Type: Century Limited, 4-door sedan
Driver: 80-year-old male	Driver: 76-year-old female
CDC: 12-FREW-2	CDC: 12-FREW-2

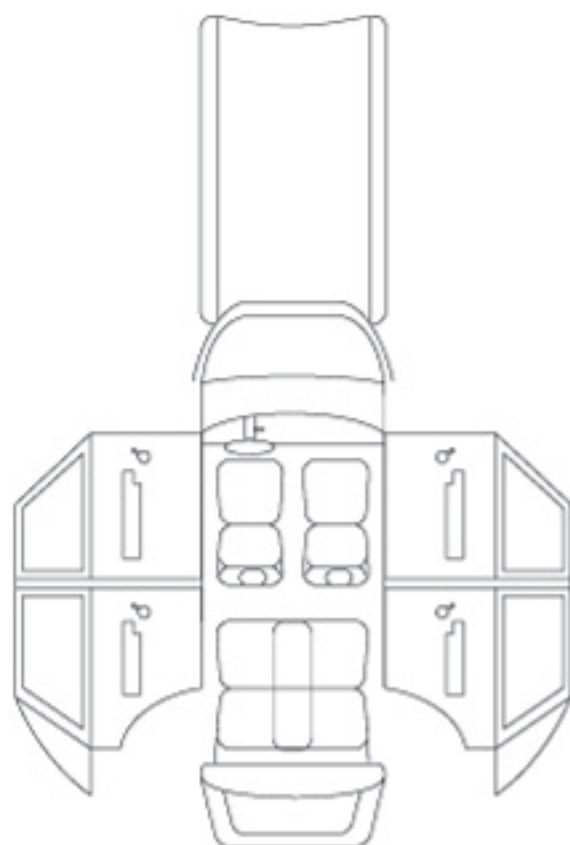
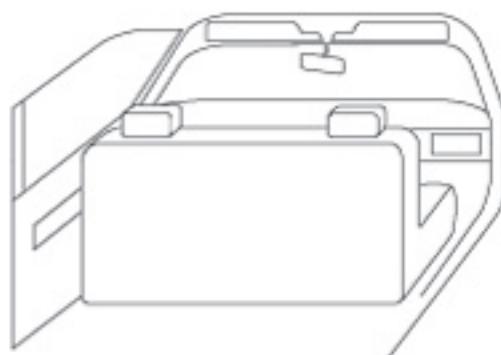
**DR belt evidence of use:**  
marks on D-ring and webbing up on B-pillar

**RF belt evidence of use:**  
marks on D-ring, webbing and continuous loop, up on B-pillar

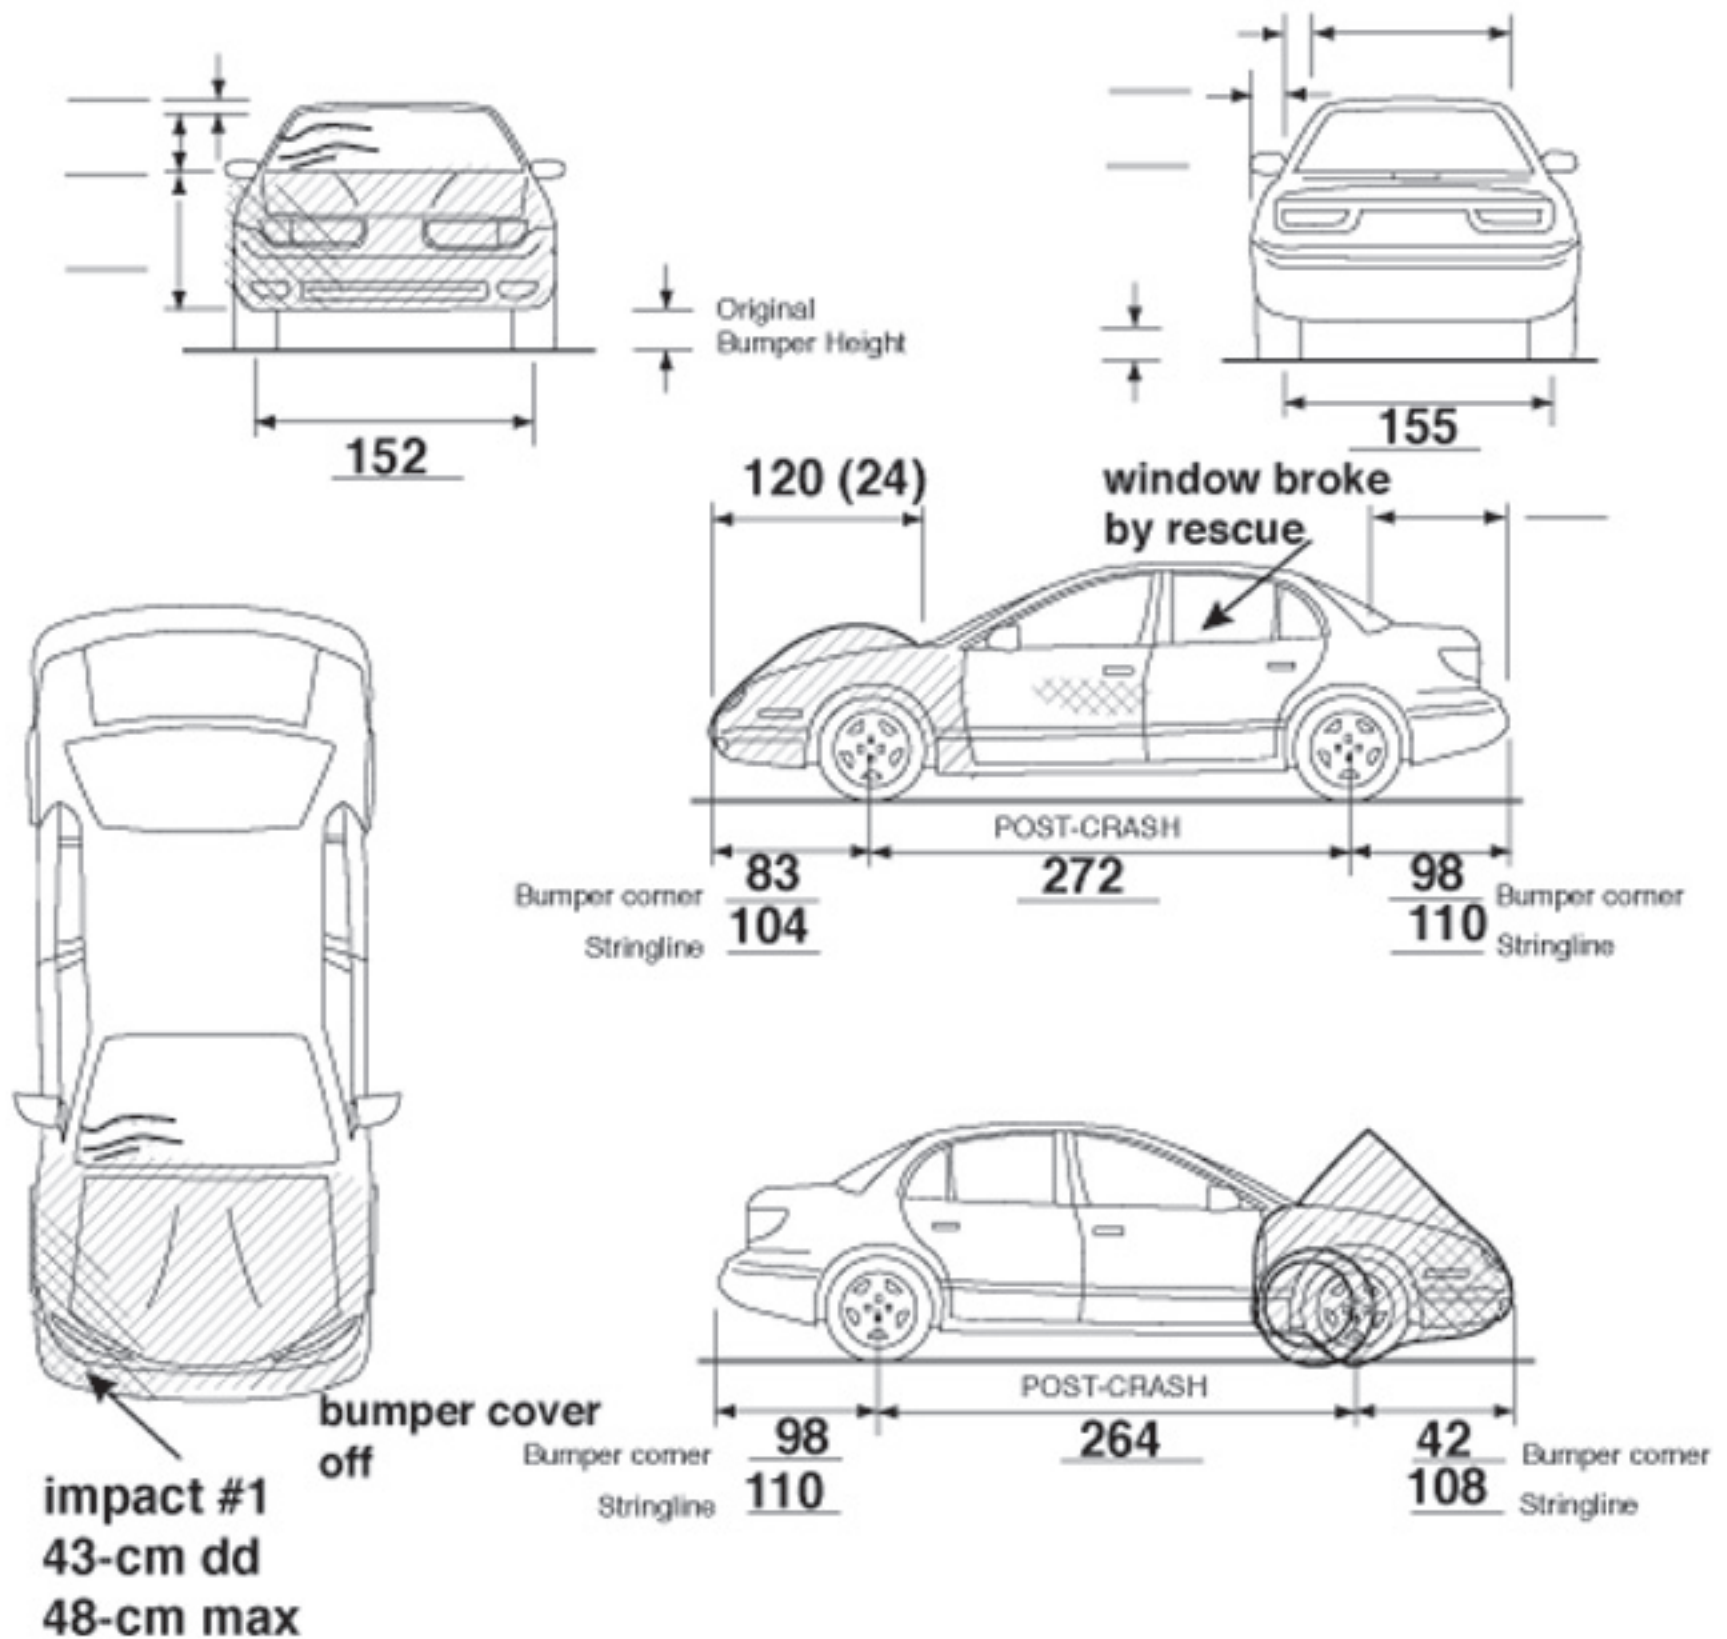
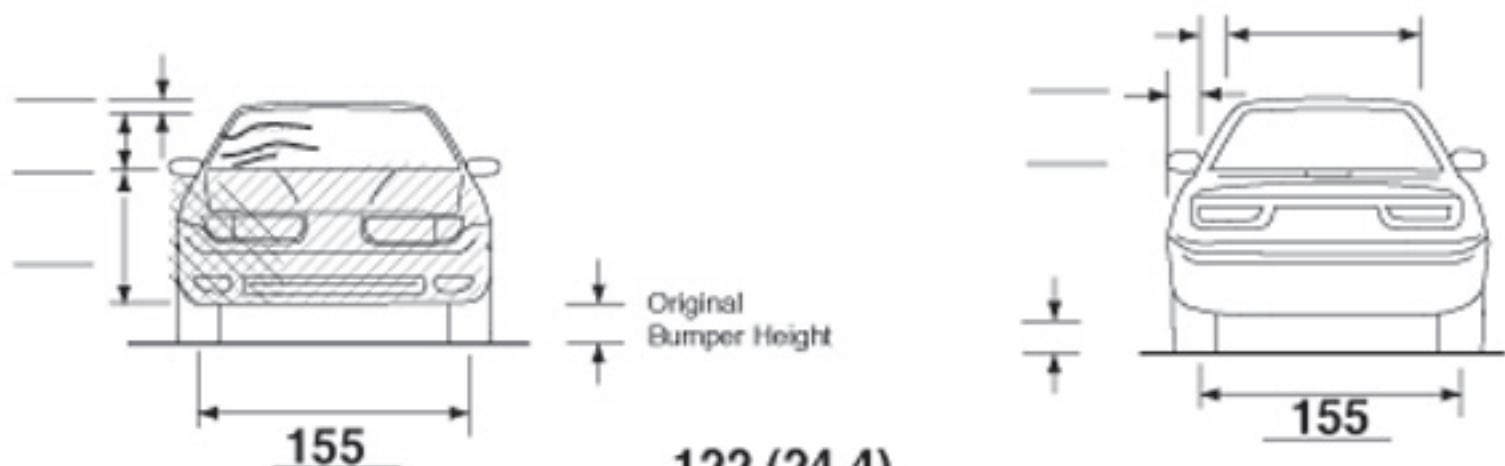
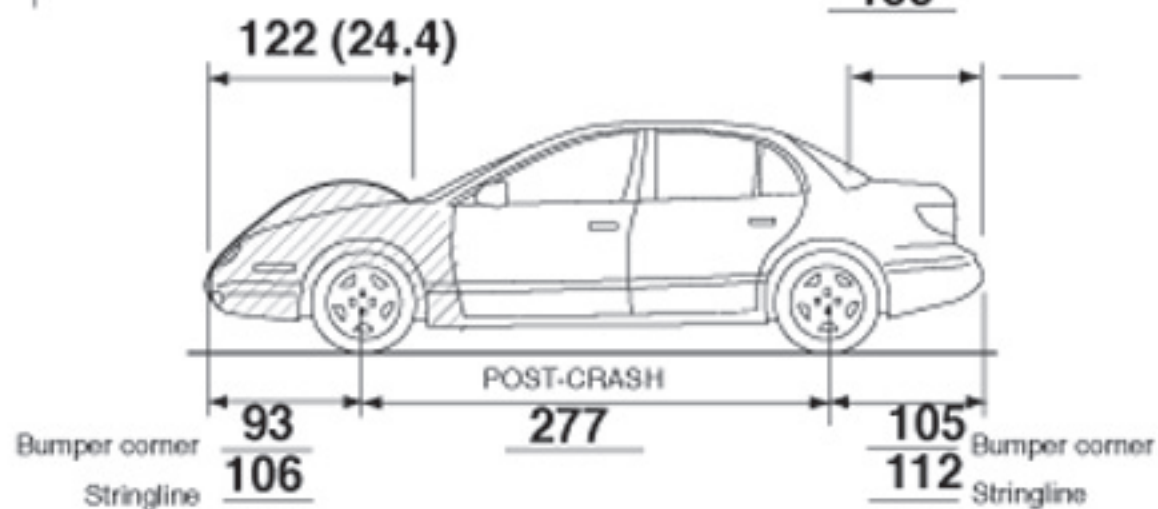
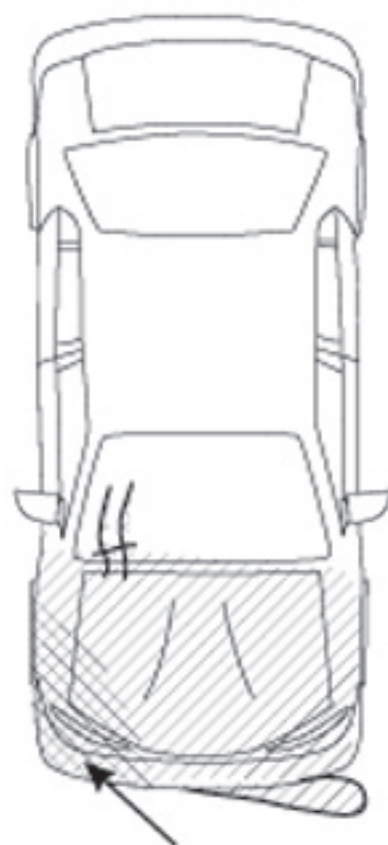
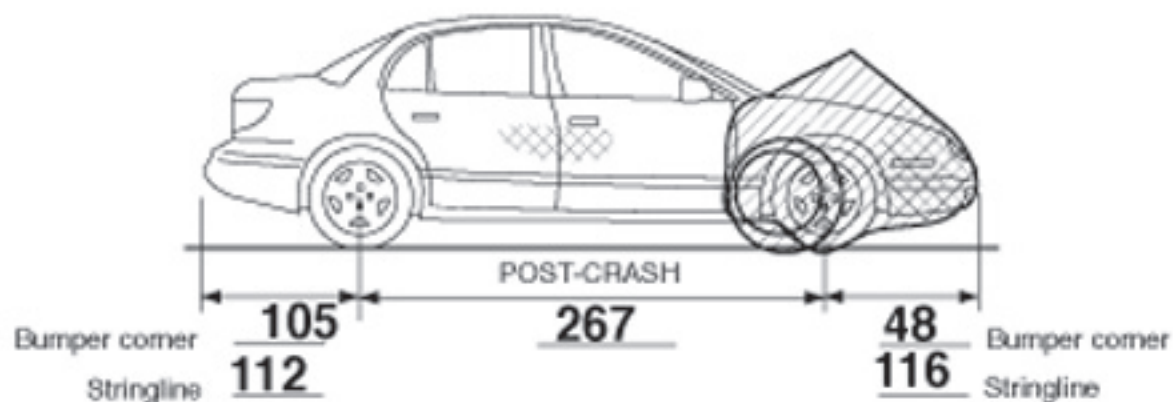
**impact #1**  
**48-cm dd**  
**46-cm max**
